Purpose

These test instructions are intended to carry out and document the visual inspection of the specified weld seams of the stand-up unit.

Photo documentation/error examples of weld seams

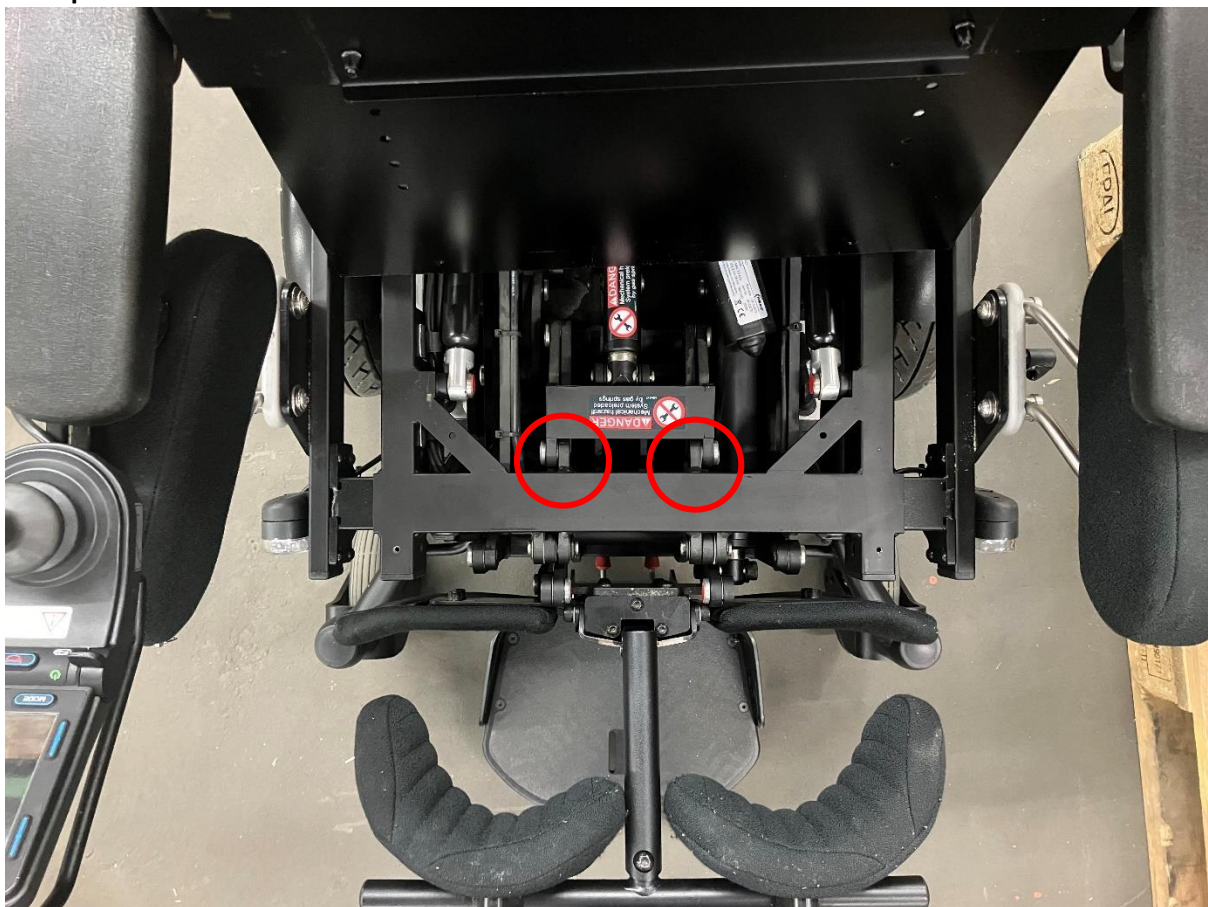
Example failure 1

The two weld seams and the surrounding area must be subjected to a visual inspection and must not show any of the damage/defects listed in the photo documentation, such as cracks, sheet metal elevations, separation of the seam or rust in the weld seam area.

If the test shows one of the defects mentioned, Meyra must be informed immediately. The affected product may no longer be used until it has been technically checked or repaired by Meyra or specialist personnel authorized by Meyra.
